SR 108 MP 9.47 Kamilche Creek: Preliminary Hydraulic Design Report

**Shaun Bevan PE, Water Resources Engineer
HDR Engineering, Inc.**

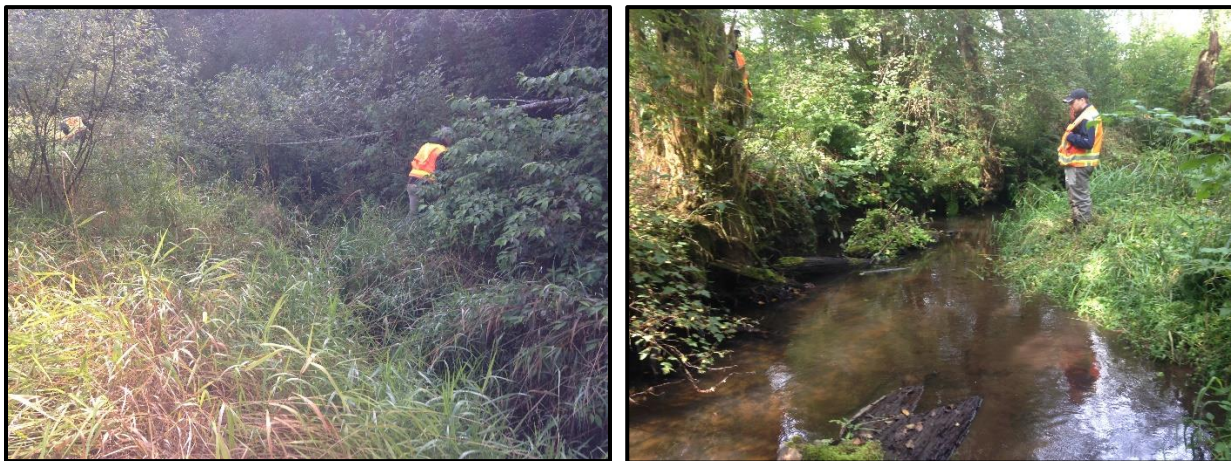
Figure 11 Channel upstream of culvert inlet (left) and channel downstream of culvert outlet (right)

Channel bed features include pools, a wetland complex, and an incised stream channel upstream of the culvert inlet with depth of incision ranging from 2 to 3 feet. Potential beaver activity appears to have contributed to the formation of both the pool and the wetland complex within the stream corridor upstream of the SR 108 crossing. A tributary flows into the channel from river left looking downstream, just upstream of the SR 108 crossing. The tributary contributes to the pool that has formed just upstream of the culvert inlet.

Downstream of the culvert outlet, the channel was observed to be artificially widened upstream of a debris jam, potentially due to further beaver activity, which spans approximately three-quarters of the stream channel. Below the pool, the stream was observed to be slightly incised with evidence of undercut banks (Figure 11). Approximately 80 feet downstream of the culvert outlet, an approximately 2-foot wide tributary enters the stream from river left looking downstream. Several mid-channel sediment bars were encountered within the reach.

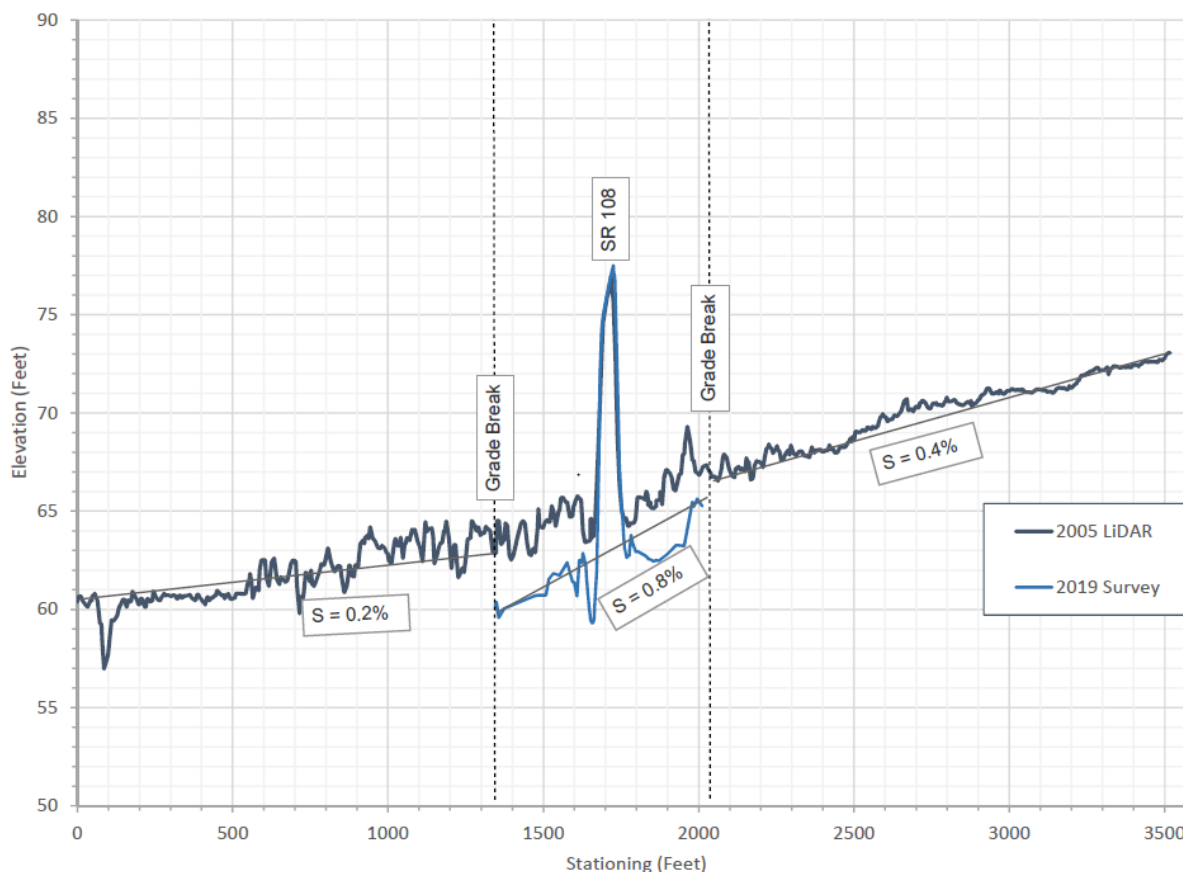
Figure 12 Long profile of Kamilche Creek near SR 108 crossing

A long channel profile was developed from the 2019 survey data and 2005 Puget Sound Lowlands LiDAR data (Figure 12). Upstream of the project area, the average reach slope is 0.4 percent. Within the

detailed survey, the reach slope increases to an average of 0.8 percent. The reach downstream of the survey is less steep, with an average slope of 0.2 percent.

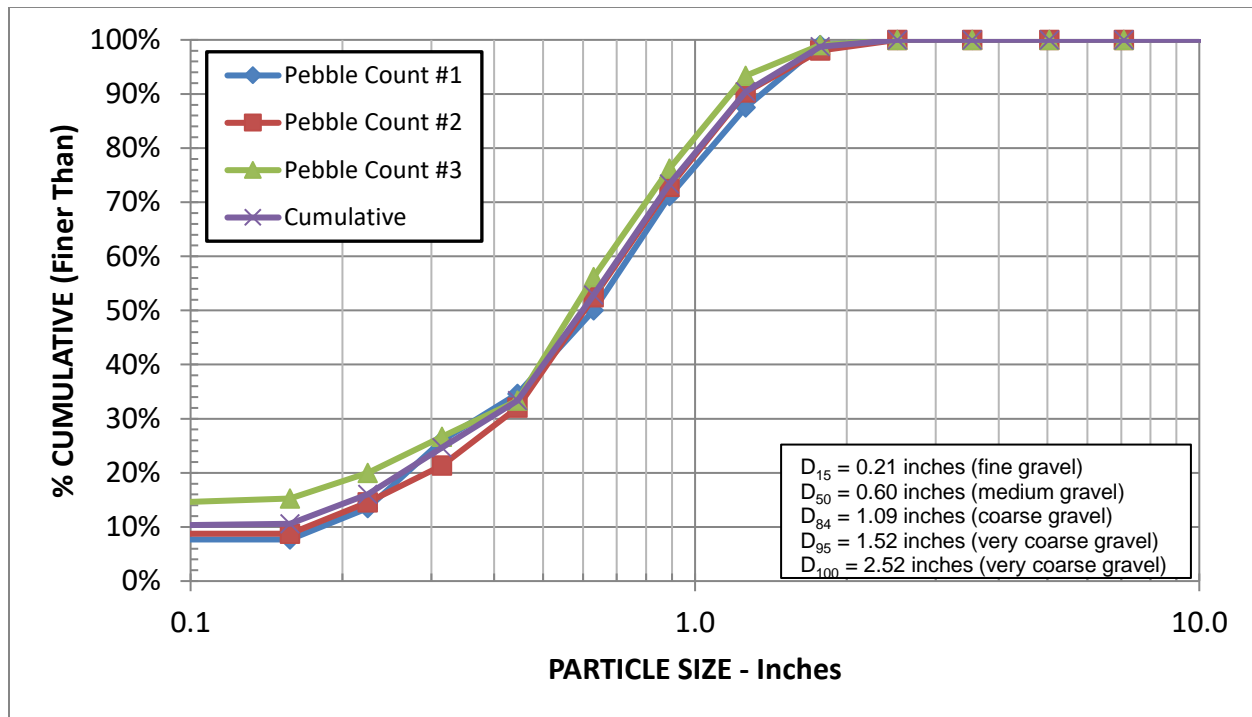
Figure 13 Sediment size distribution

The streambed substrate upstream of the culvert inlet appeared to be dominated by fine silt and sand material with minimal gravel and cobbles present. Downstream, the streambed substrate contains more small gravels and cobbles, with several sediment bars observed along the reach. Streambed boulders were not observed within the limits of the site visit for this stream. Three pebble counts were taken in the downstream reach during the site reconnaissance and the cumulative results of the sediment size distribution are compiled in the graph (Figure 13) and table below (Table 1). Figure 14 includes a picture of the typical substrate size observed.

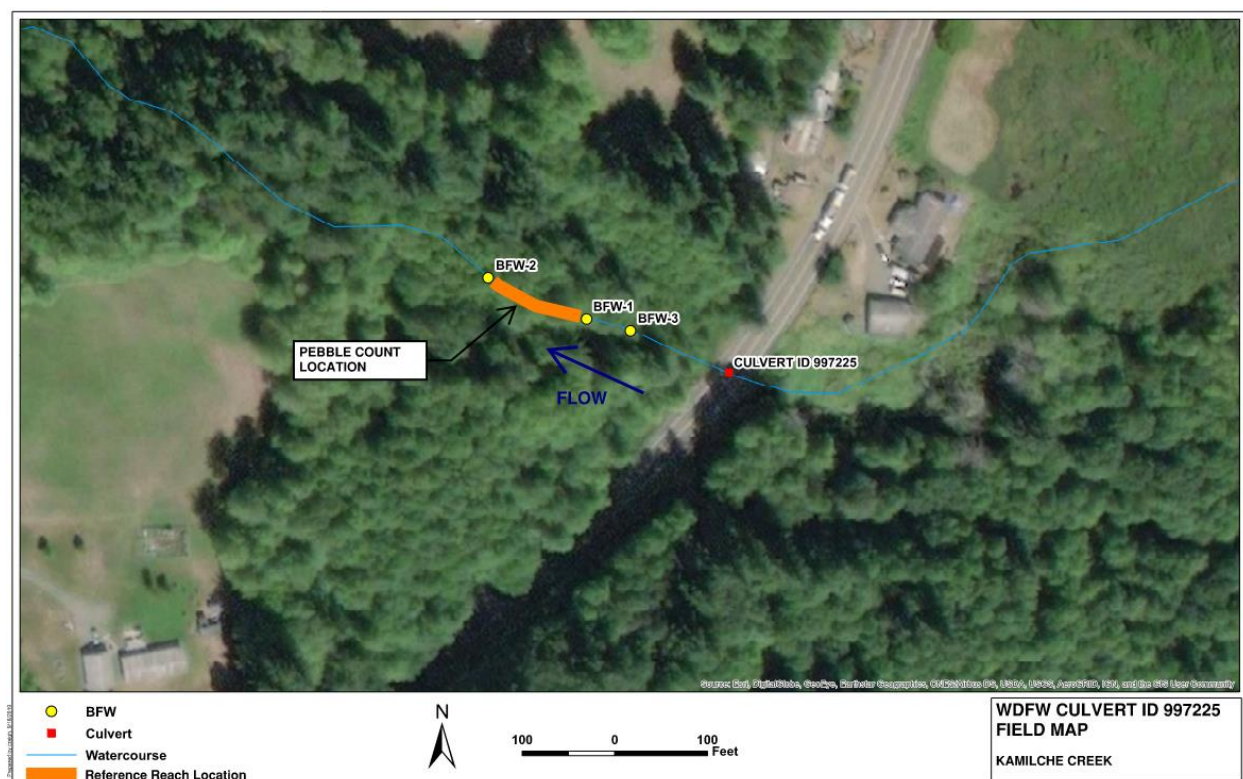
Figure 16 Bankfull width and pebble count measurement locations

During the August 23, 2019 site visit, the field team observed approximately 300 feet upstream and 300 feet downstream of the Kamilche Creek culvert crossing at SR 108. A reference reach was selected downstream of the crossing between bankfull width 1 (BFW 1) and bankfull width 2 (BFW 2), downstream of the scour pool that currently exists at the culvert outlet. This reach was deemed the most representative natural stream reach and is shown in Figure 16.

During the stakeholder site visit with WDFW, it was agreed upon to average the three previously collected bankfull widths and one additional bankfull width (16.5 feet) collected upstream. This additional bankfull width was collected upstream, approximately 15 feet downstream from the beaver dam, during the stakeholder site visit. Averaging these four bankfull widths results in a design bankfull width of 16 feet.

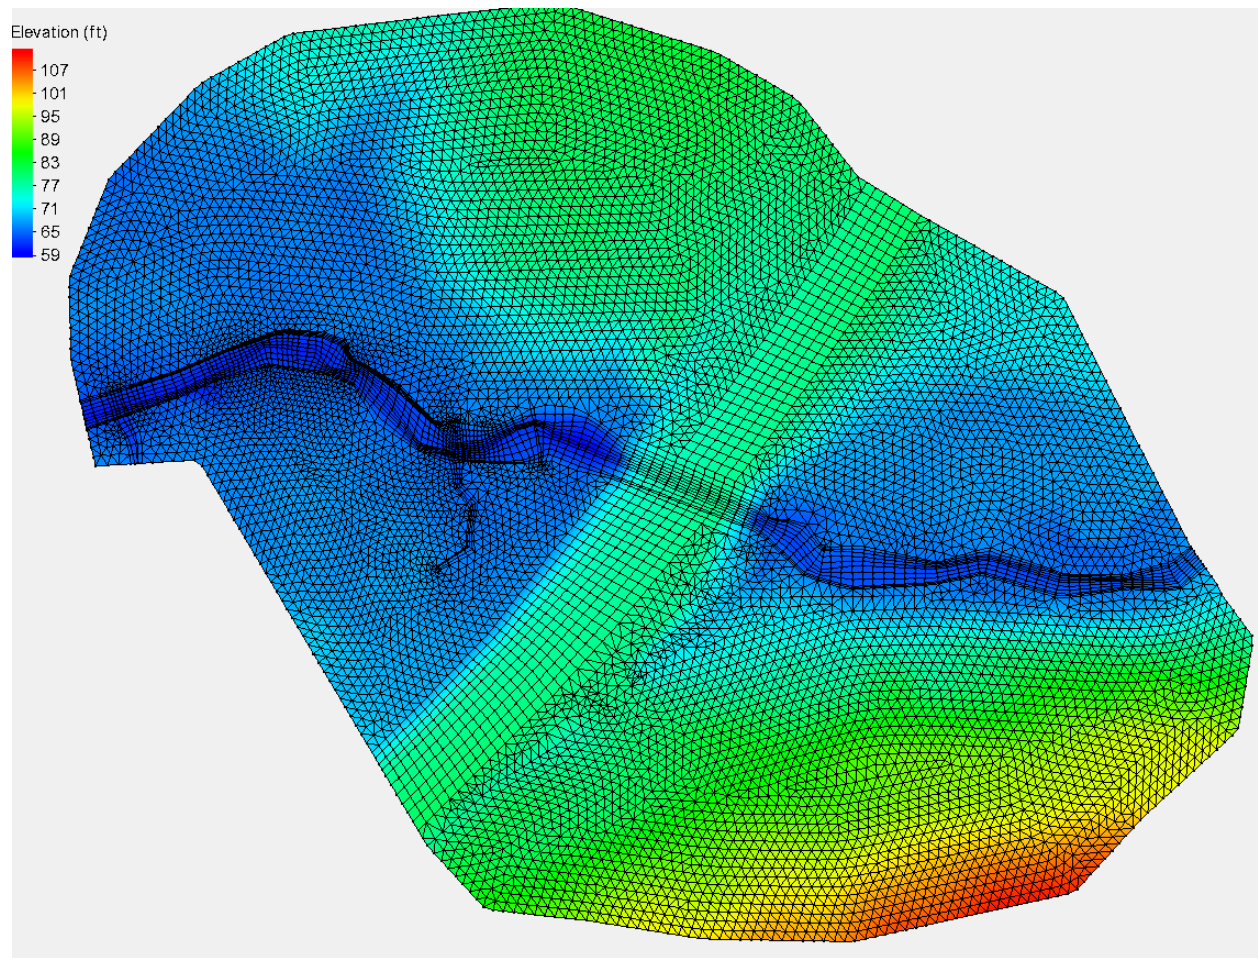
Figure 17 Existing computational mesh with underlying terrain

The hydraulic model upstream and downstream extents are consistent with the detailed survey boundary, approximately 225 feet upstream of the existing culvert outlet and 290 feet downstream of the existing culvert outlet, measured along the channel centerline. The left and right banks were supplemented with LiDAR data to capture the full extents of floodplain over the range of modeled flows (Figure 17). The computational mesh elements was a combination of patched and paved (triangular) elements, with finer resolution in the channel and larger elements in the floodplain.

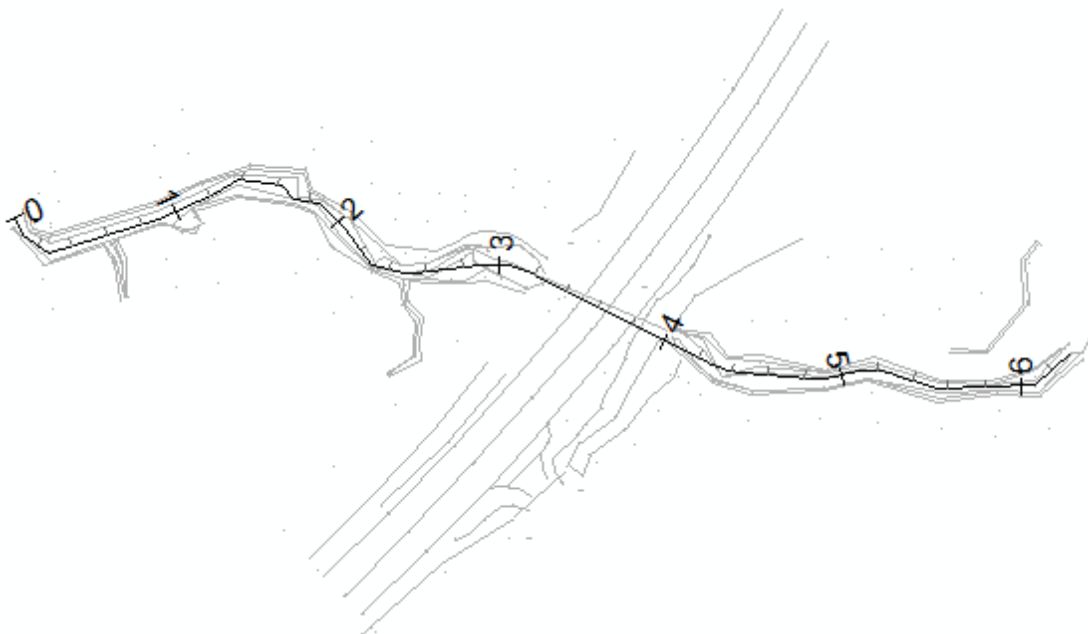
Figure 19 Longitudinal profile stationing for existing and proposed conditions

In addition to cross section results, results were summarized along the channel longitudinal profile. Both existing and proposed condition hydraulic results were reported using the same alignment (Figure 19).

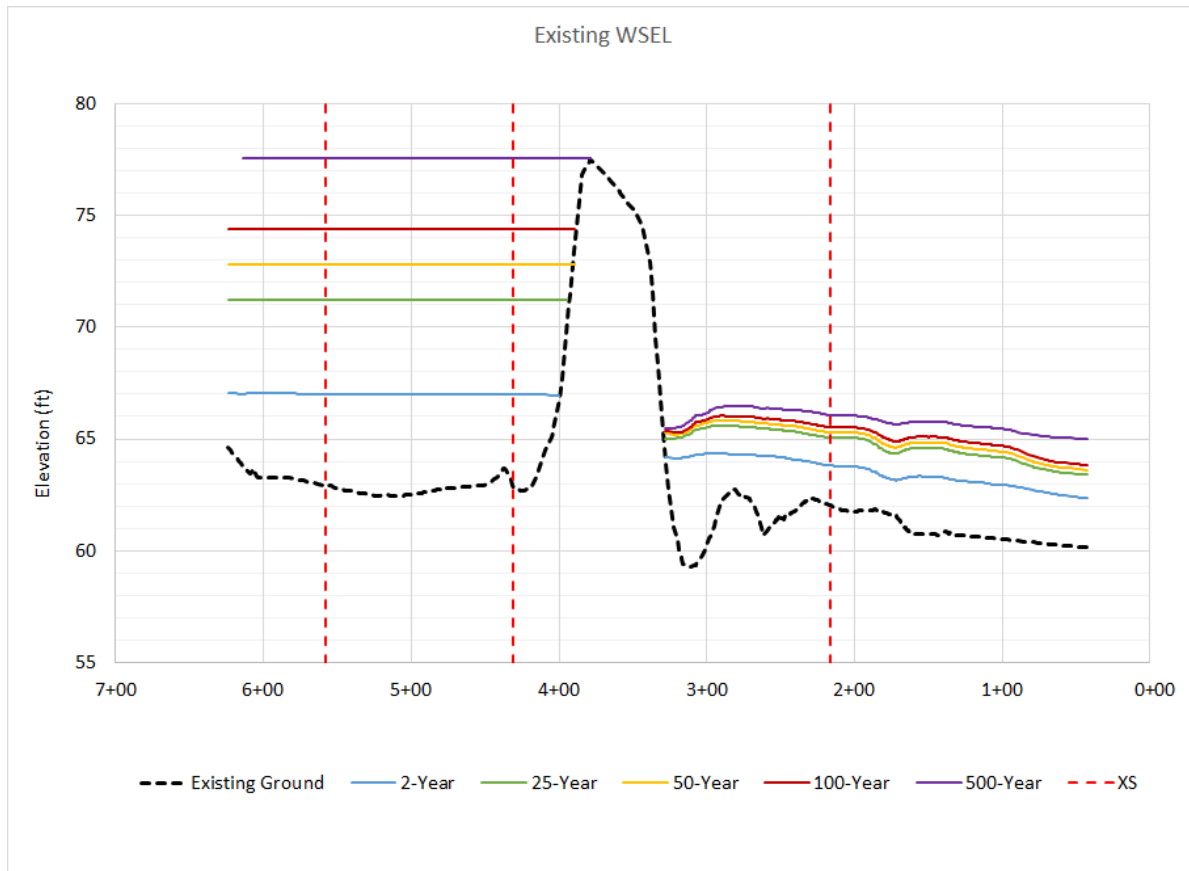
Figure 20 Existing conditions water surface profiles

Existing conditions hydraulic results are summarized for the upstream and downstream cross sections in Table 5 below. Under existing conditions, the culvert causes a backwater upstream for the range of flows simulated (Figure 20). Pressure flow conditions were first observed during the 25-year event simulation. The existing roadway was overtopped by the 500-year event.

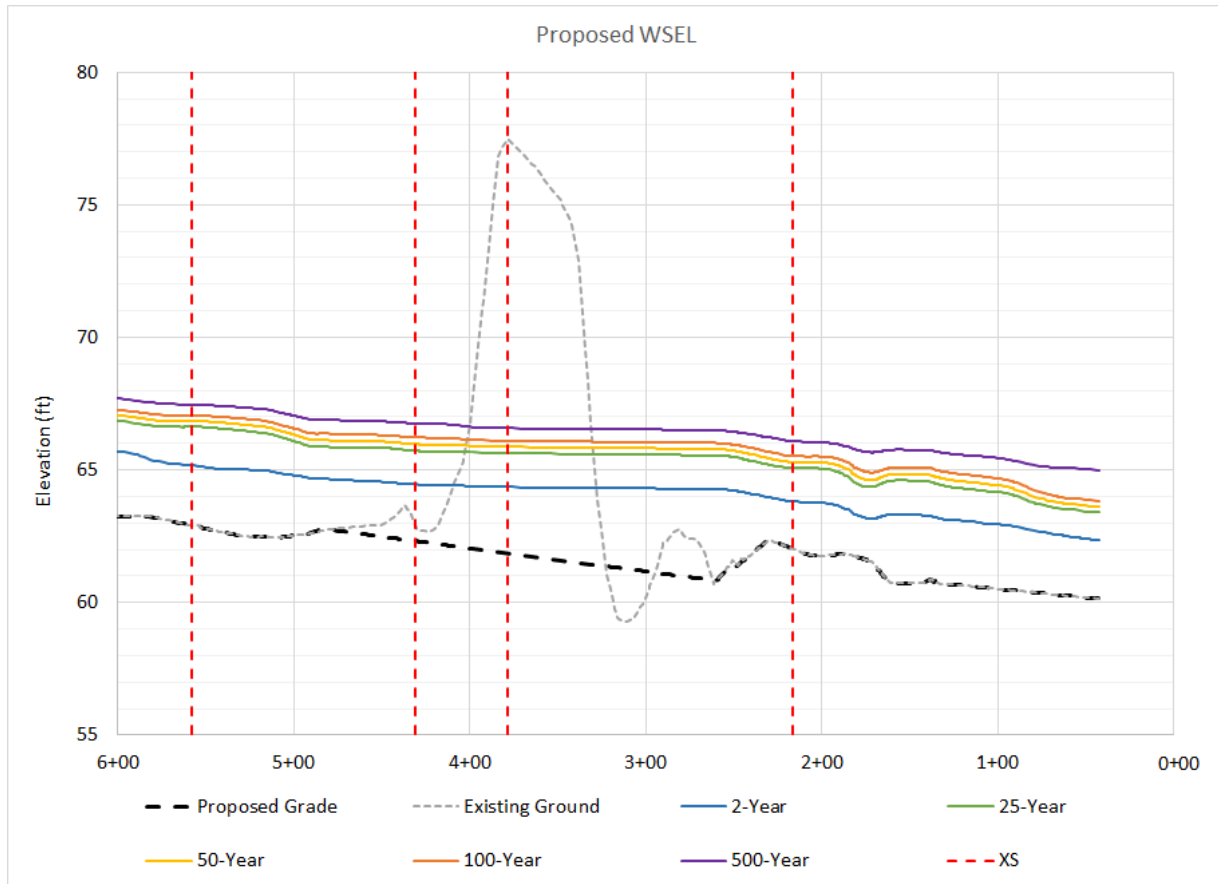
Figure 22 Proposed conditions water surface profiles

Proposed conditions hydraulic results are summarized in Table 6. The proposed crossing is located at cross section STA 3+78. The larger proposed structure reduced water surface elevations upstream and did not result in any backwater (Figure 22). The 100-year water surface elevation upstream of the crossing was decreased by 7.7 feet when compared to existing conditions.

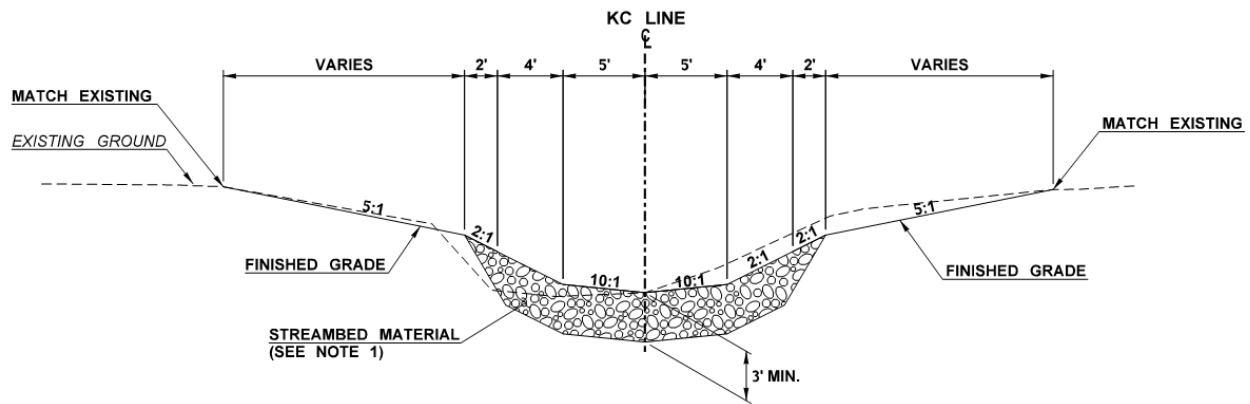
Figure 24 Typical downstream channel section (looking upstream)

The WCDG requires that the channel planform and shape mimic conditions within a reference reach. The proposed channel shape includes 10H:1V slopes between the toes and 2H:1V bank slopes above the toe for 6 feet horizontally to create a 3-foot high bank. Above the 2H:1V bank slopes the grading transitions to 5H:1V to match existing grade (Figure 24). Upstream of the bridge the 5H:1V is not incorporated into the grading as the bank highs are already low, so the 2H:1V is used from the toe of the bank to catch existing grade, see Figure 25.

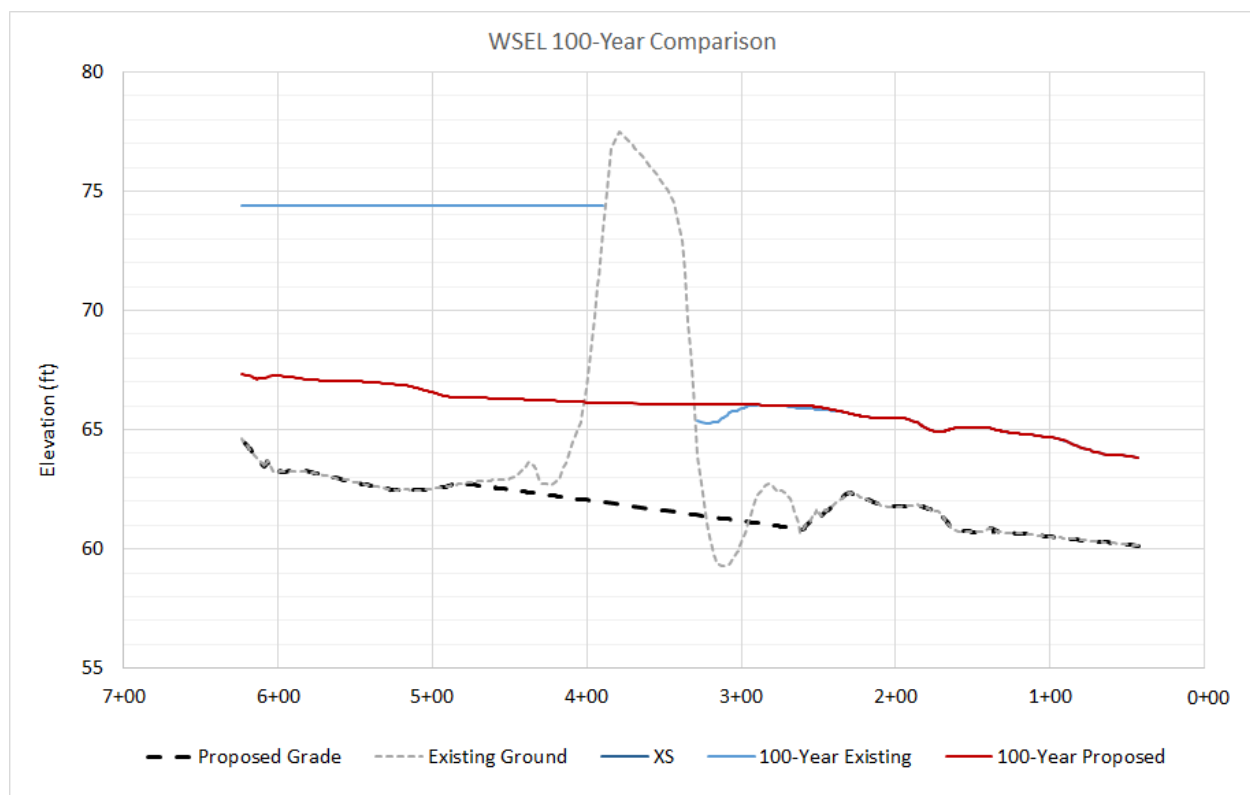
Figure 27 Existing and proposed 100-Year water surface profile comparison

Installation of the proposed structure will eliminate the backwater impacts upstream of the existing culvert, resulting in a reduction in water surface elevation. Preliminary hydraulic results indicate that there is a reduction in water surface elevation of 7.7 and 10.8 feet during the 100 and 500-year events at the upstream cross section, respectively. Just downstream of the culvert, the proposed grading fills the scour pool, creating a water surface elevations increase of approximately 1.2 feet during the 100 year event.

Figure 27 provides a comparison of the existing and proposed 100-year water surface profile, showing the areas of increase of greater than 0.1 feet during proposed conditions. The hydraulic simulations indicate an increase in water surface elevations downstream of the proposed crossing with a maximum increase of approximately 0.7 feet. The increase in water surface can be attributed to the filling of the scour pool downstream. Increases in the 100-year water surface are illustrated in Figure 28.
